**Professional Inspections Incorporated Inspection Report**

**YOUR  
INSPECTION  
REPORT**

5431 Tory Hill Drive  
Greensboro, N.C. 27410-9333

April 13, 2017

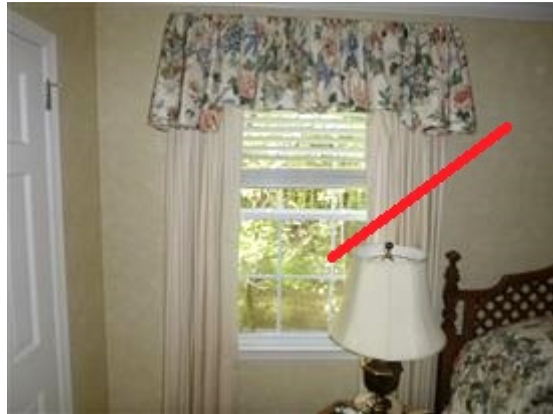
**3b. WINDOWS / COUNTERBALANCE** - The bank of double hung windows along the back wall of the sunroom all have weakened window sash counterbalance. The lower sash will not stay in the open position without some means of support being placed beneath the bottom rail. Further evaluation and correction by a window technician is warranted.

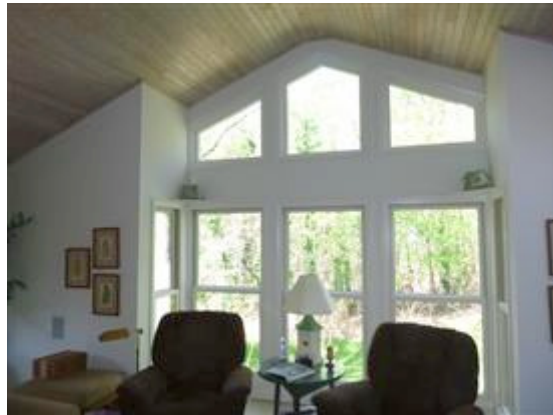
**4a. EXTERIOR SLIDING DOORS** - The lock does not engage the adjoining strike plate at the right end sunroom doors that look out toward the driveway. Further evaluation and adjustment to correct this condition is warranted.

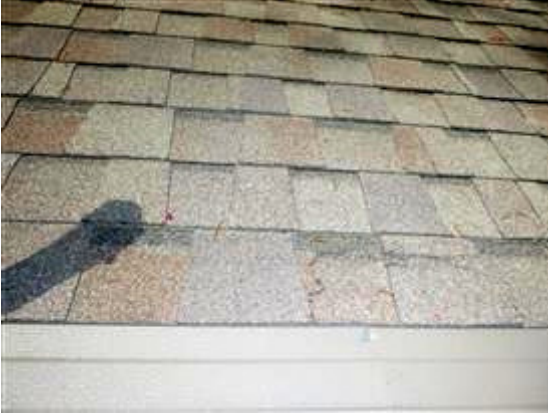
**1b. SHINGLES** - The Inspector did not observe any abnormal wear and tear or evidence of leak activity associated with the roofing shingles at time of the inspection other than that noted above. The home owner has indicated that the shingles were installed in 2010. 25 year wear rated architectural shingles have an average life expectancy of 20 to 25 years. The wear rating for the shingles observed at time of the inspection is not known, however, are at least 25 year rated.

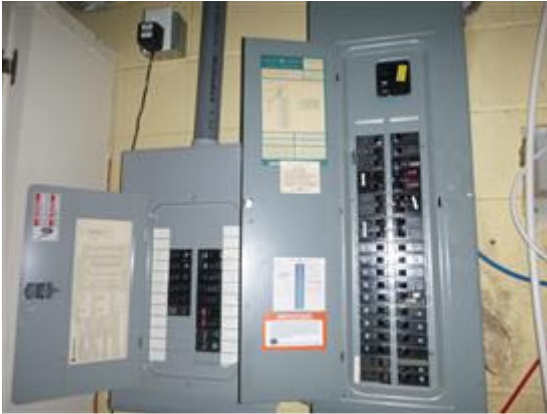
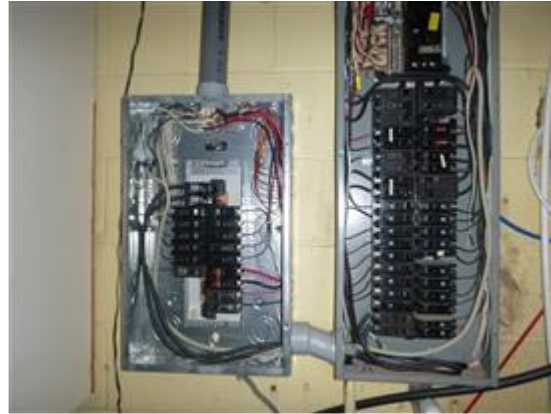
**4. PANEL BOX WIRING** - Two conductor wires; a hot and neutral have been improperly terminated and left in the right hand panel box. The subject wires do not include wire nuts as would be expected. Several wiring practices observed during the bus bar inspection in the primary panel box would be considered improper present day. Double tapped neutral wires beneath a common bus bar screw and neutral and ground wires double tapped together under a common bus bar screw were both observed. Further evaluation of the above noted conditions by a licensed electrical contractor is warranted. Corrective measures should be taken as determined necessary.

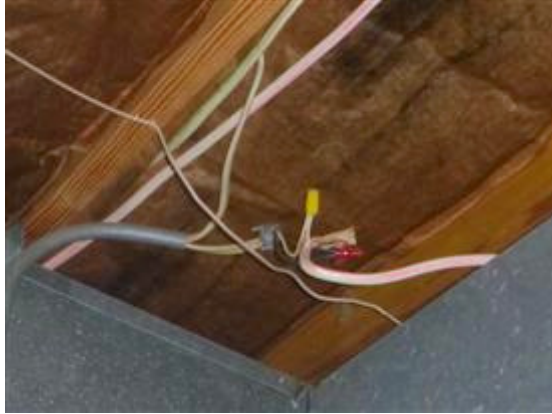
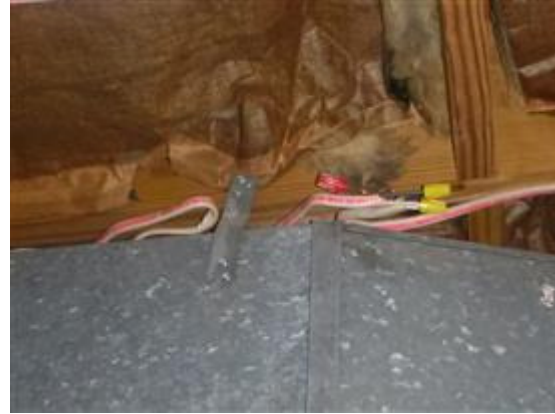
**8b. WIRING TO OTHER ELECTRICAL EQUIPMENT** - The wiring observed inside the closet at the front end of the central hallway does not reflect that of a licensed electrical contractor. Conductor wires enter the metal junction box without the benefit of a cable connector and/or bushing to protect the wires from the sharp edges of the metal knockout. Further evaluation of the above noted condition by a licensed electrical contractor is warranted. Corrective measures should be made as determined necessary.

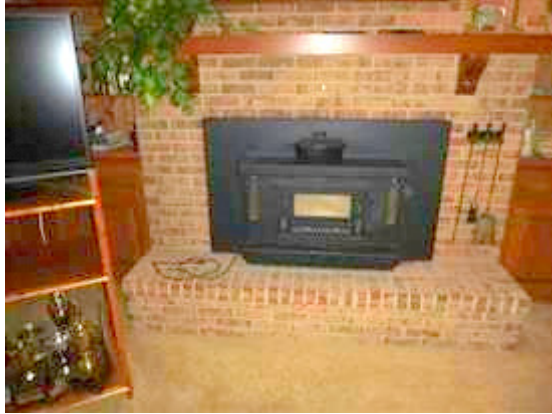
**3. GAS LOGS** - The fireplace is equipped with gas logs; however, the pilot light was not on at time of the inspection. Due to insurance liability an attempt to light the pilot was not made. An opinion as to the operating condition of the gas logs is not offered. I recommend that you have the owner or owner's representative demonstrate the use of the gas logs prior to closing.

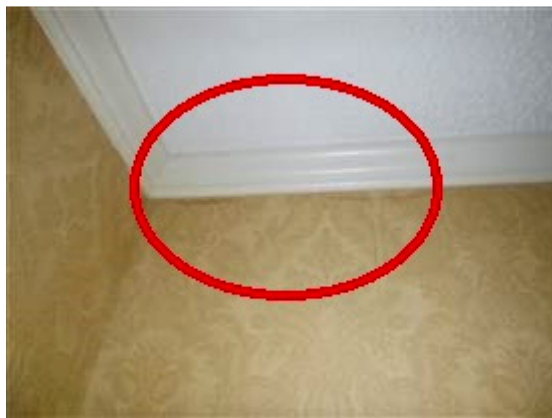
**2a. CEILING** - What appear to be old water stains were observed on the kitchen dining area ceiling in close proximity to the light fixture. I suggest you inquire of the present owner for any information pertaining to the above noted condition. If the home owner is not aware of the stain, further evaluation may be desired.
