**Professional Inspections Incorporated Inspection Report**

**YOUR  
INSPECTION  
REPORT**

5431 Tory Hill Drive  
Greensboro, N.C. 27410-9333

April 13, 2017

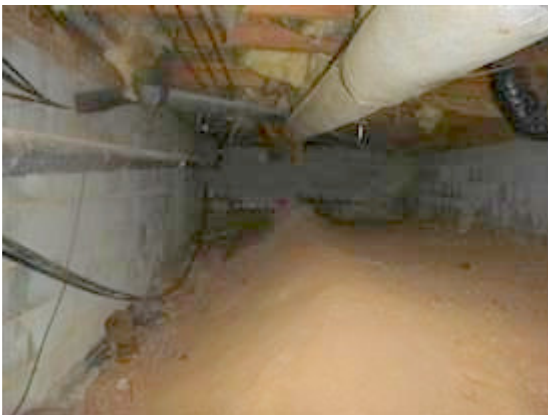
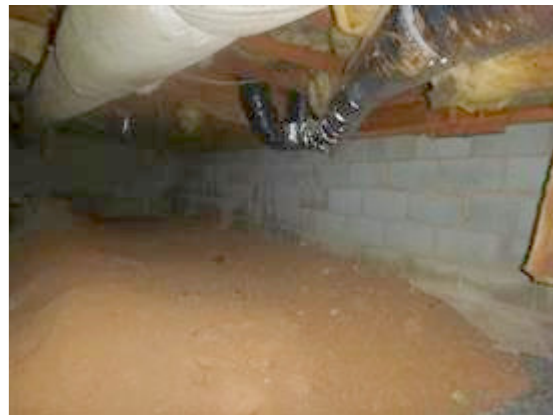
**13. VAPOR BARRIER** - The crawlspace does not include a plastic vapor barrier as would be required present day. The installation of a vapor barrier is recommended to prevent ground moisture from adding to the relative humidity in the crawlspace. The vapor barrier should cover as much of the exposed ground as possible. **The above noted recommendation should not be considered a requirement of the present owner.**

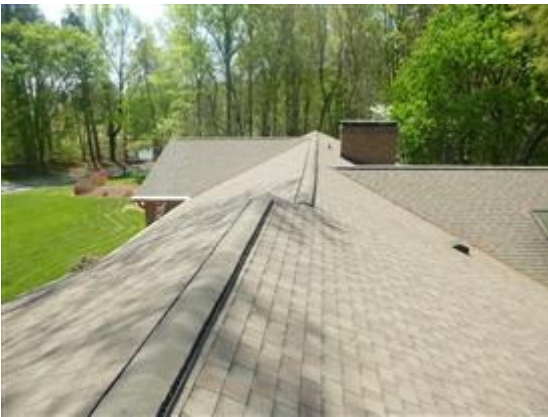
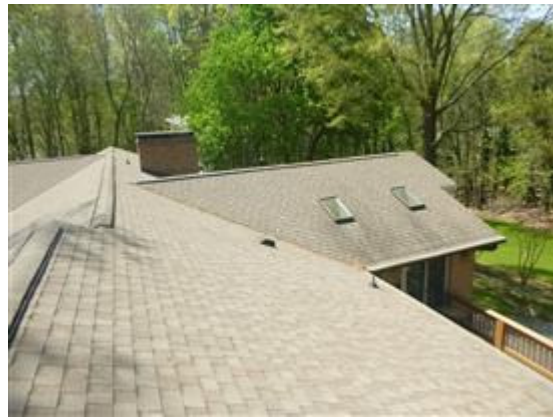
**1b. SHINGLES** - The Inspector did not observe any abnormal wear and tear or evidence of leak activity associated with the roofing shingles at time of the inspection other than that noted above. The home owner has indicated that the shingles were installed in 2010. 25 year wear rated architectural shingles have an average life expectancy of 20 to 25 years. The wear rating for the shingles observed at time of the inspection is not known, however, are at least 25 year rated.

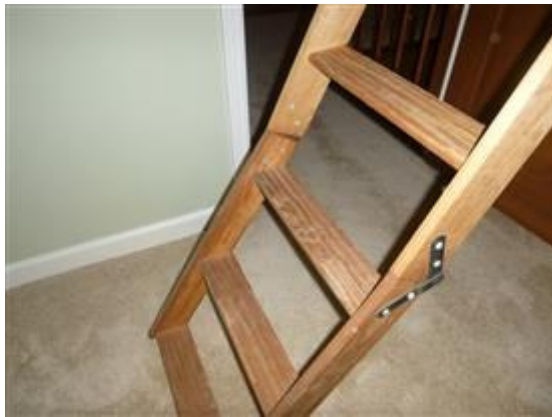
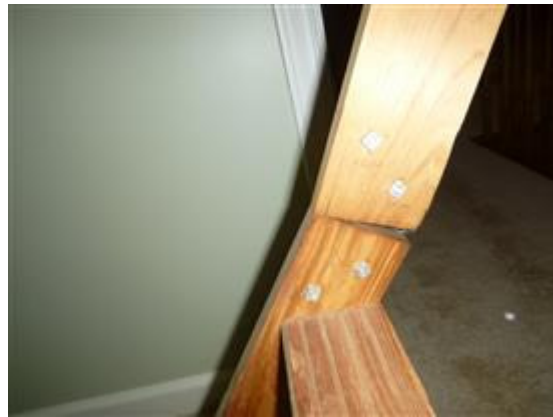
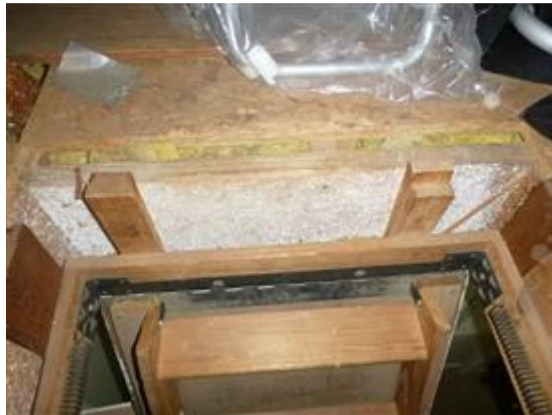
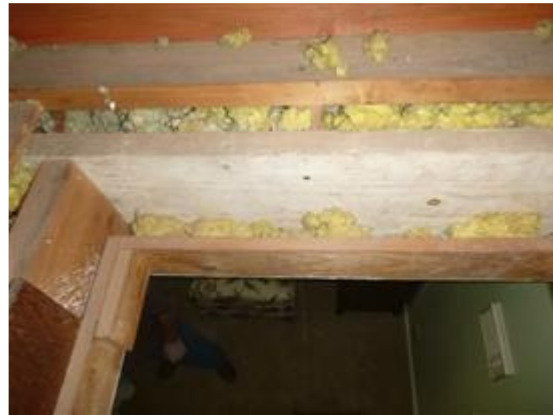
**12. PULL DOWN STAIRCASE** - The staircase stringers are too long; preventing the joints from lining up with each other. The above noted condition adversely affects the structural stability of the staircase. The staircase frame is not properly secured in place. Finish nails have been used in lieu of 16 penny framing nails as is generally recommended by the staircase manufacturers. Further evaluation and correction is warranted due to safety concerns.

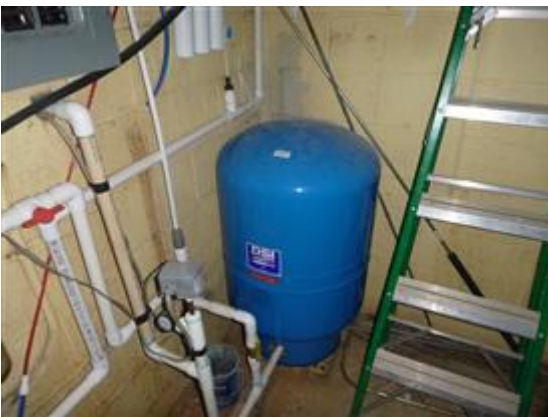
**17. WELL PUMP / STORAGE TANK** - The well pump is believed to be submerged in the well itself. The storage tank is located in the basement workshop. Both components are believed to have been functioning as intended at time of the inspection.

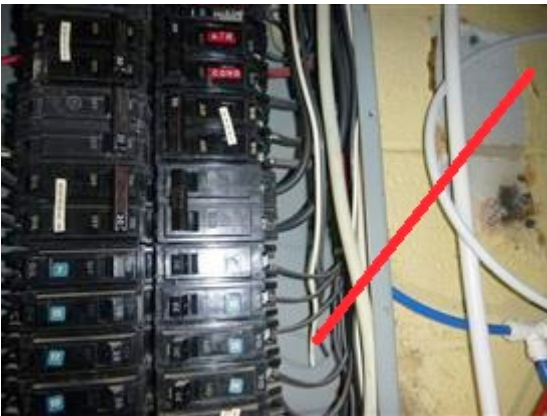
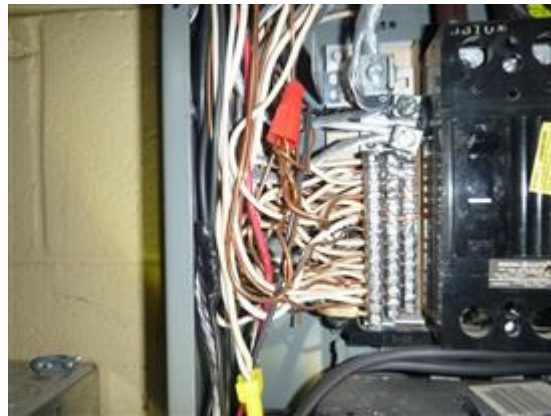
**4. PANEL BOX WIRING** - Two conductor wires; a hot and neutral have been improperly terminated and left in the right hand panel box. The subject wires do not include wire nuts as would be expected. Several wiring practices observed during the bus bar inspection in the primary panel box would be considered improper present day. Double tapped neutral wires beneath a common bus bar screw and neutral and ground wires double tapped together under a common bus bar screw were both observed. Further evaluation of the above noted conditions by a licensed electrical contractor is warranted. Corrective measures should be taken as determined necessary.

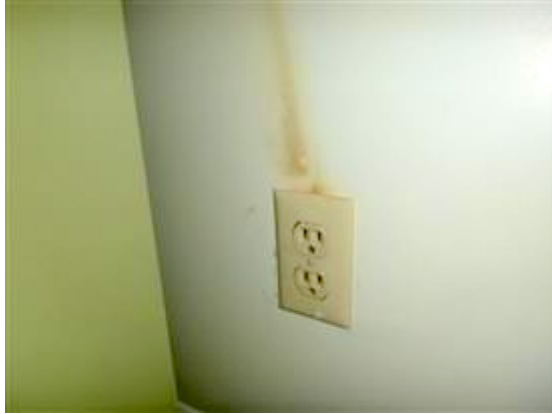
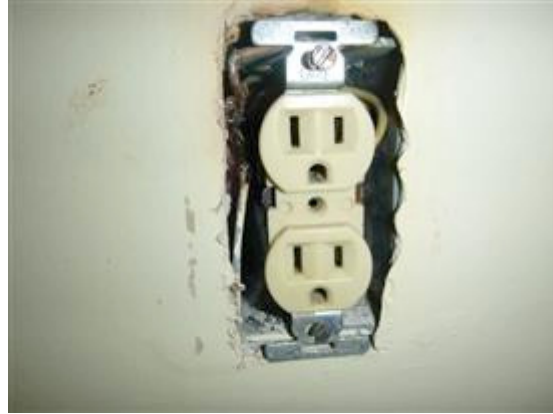
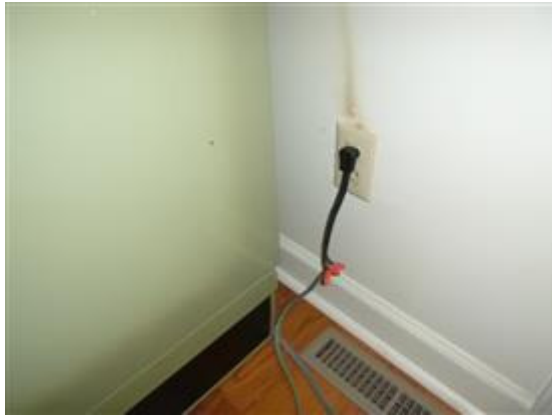
**5d. INTERIOR OUTLETS** - The outlet in the laundry room to which the freezer/refrigerator is plugged has obviously overheated in the past. The outlet itself appears to have been replaced, however, the underlying outlet box sustained heat damage. Further evaluation by a licensed electrical contractor is warranted to determine if any corrective measures are needed at this time. **NOTE: The cord being used has an exposed splice; a safety hazard.**

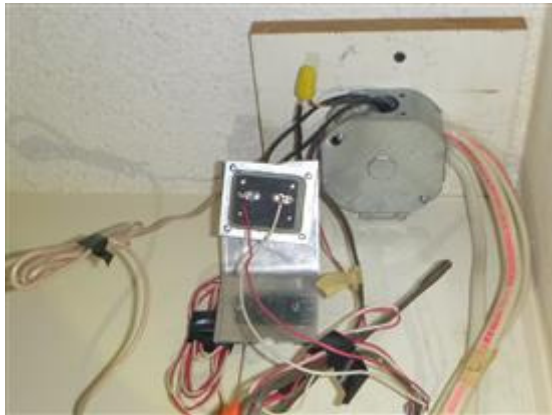
**8b. WIRING TO OTHER ELECTRICAL EQUIPMENT** - The wiring observed inside the closet at the front end of the central hallway does not reflect that of a licensed electrical contractor. Conductor wires enter the metal junction box without the benefit of a cable connector and/or bushing to protect the wires from the sharp edges of the metal knockout. Further evaluation of the above noted condition by a licensed electrical contractor is warranted. Corrective measures should be made as determined necessary.

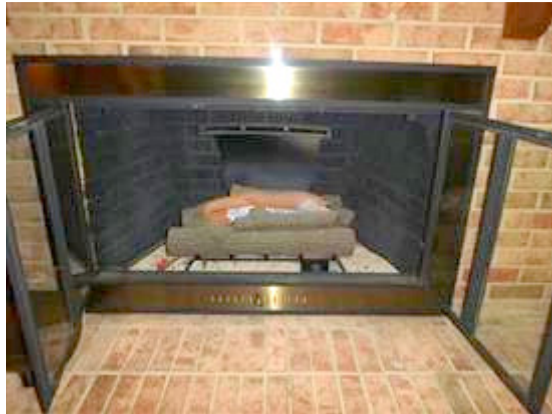
**3. GAS LOGS** - The fireplace is equipped with gas logs; however, the pilot light was not on at time of the inspection. Due to insurance liability an attempt to light the pilot was not made. An opinion as to the operating condition of the gas logs is not offered. I recommend that you have the owner or owner's representative demonstrate the use of the gas logs prior to closing.

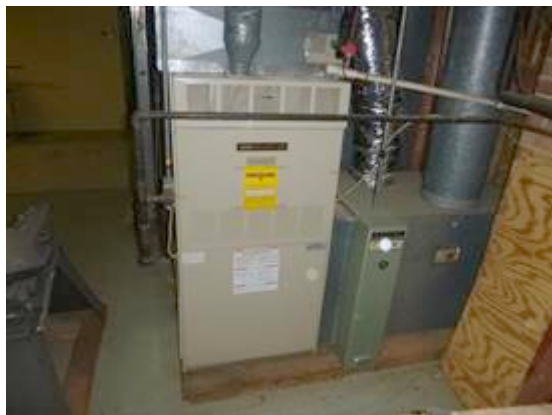
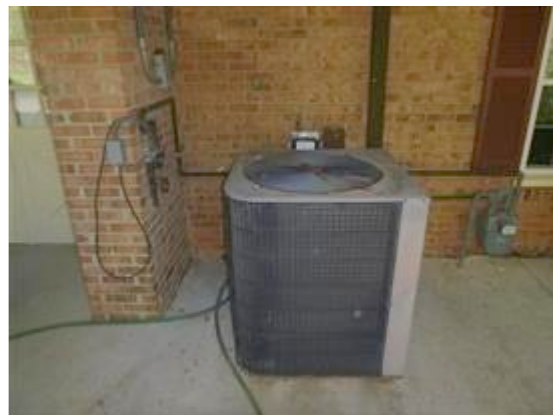
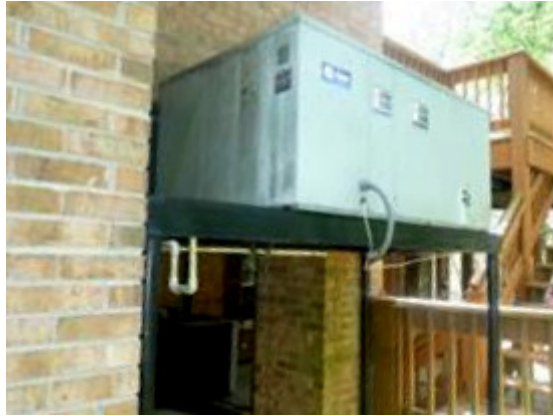
**4. & 9. H.V.A.C.** - Annual service by a licensed mechanical contractor is recommended as part of routine maintenance. The average life expectancy of properly maintained H.V.A.C. equipment is 12 to 15 years. The gas furnace and a/c unit were both manufactured in 1989; now 28 years old. The heat pump was manufactured in 1998; now 19 years old. The home owner indicated to this inspector that the equipment had not been recently serviced. A mechanical inspection and service by a licensed mechanical contractor is recommended, especially if a HOME WARRANTY is being considered.
